Situation Photo Log

Friday, July 6, 2012

Kalamazoo River / Enbridge Spill

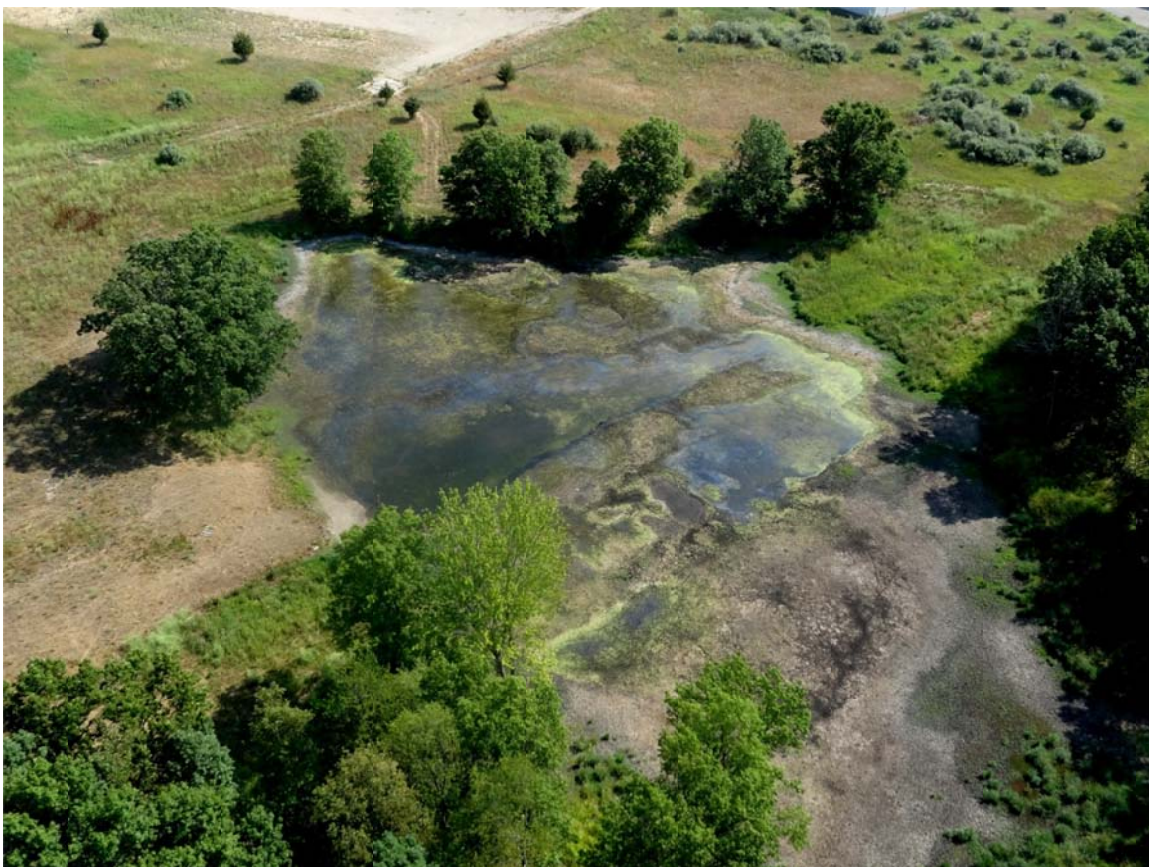
1. Source area pond, sheen observed.

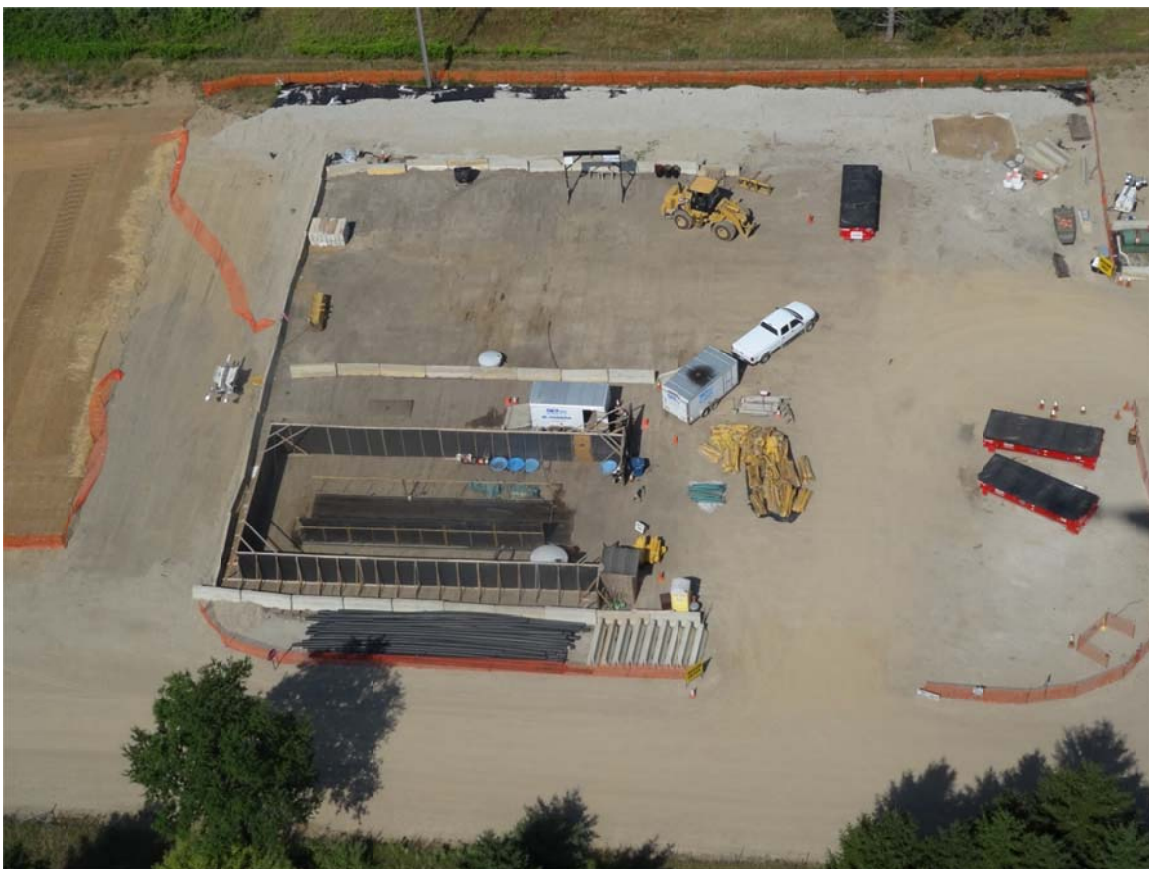
2. Frac-City, observed boom staged outside the decon pad.

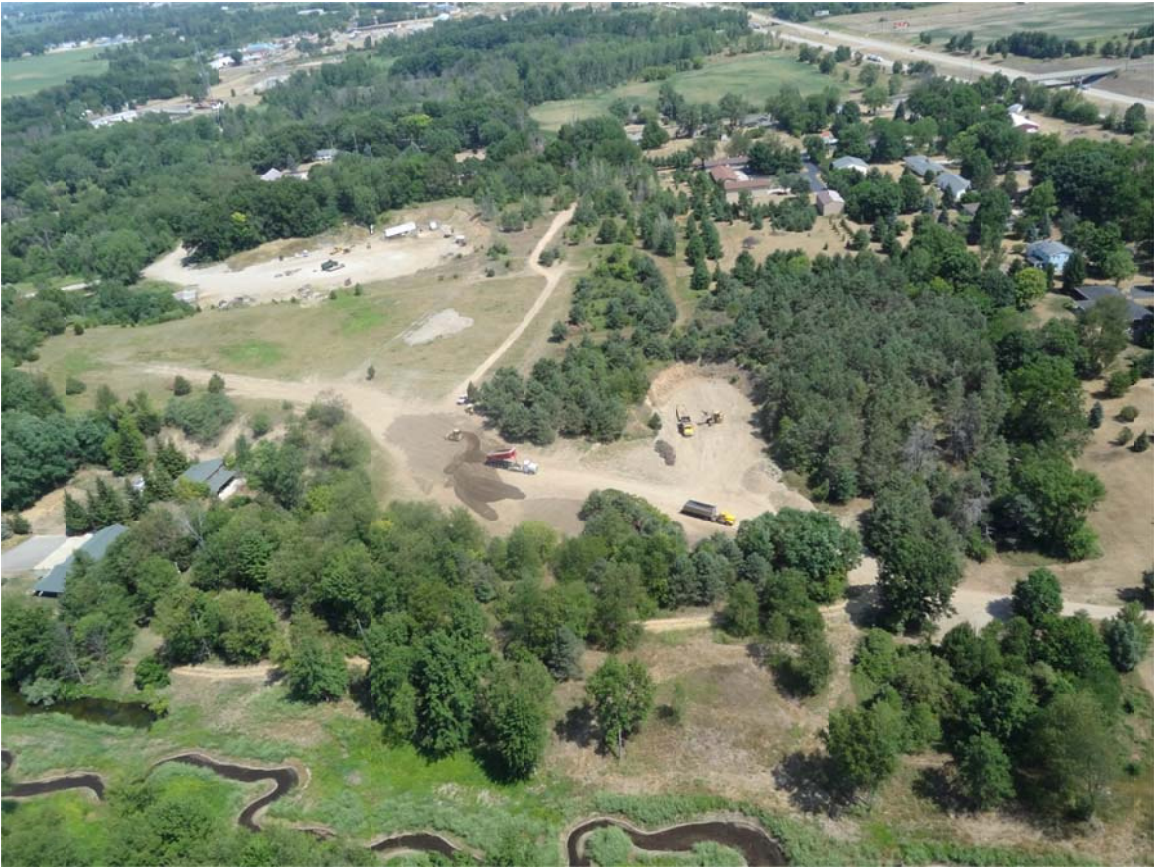
3. Former Talmadge Creek dewatering pad location. Observed truck unloading topsoil at this location.

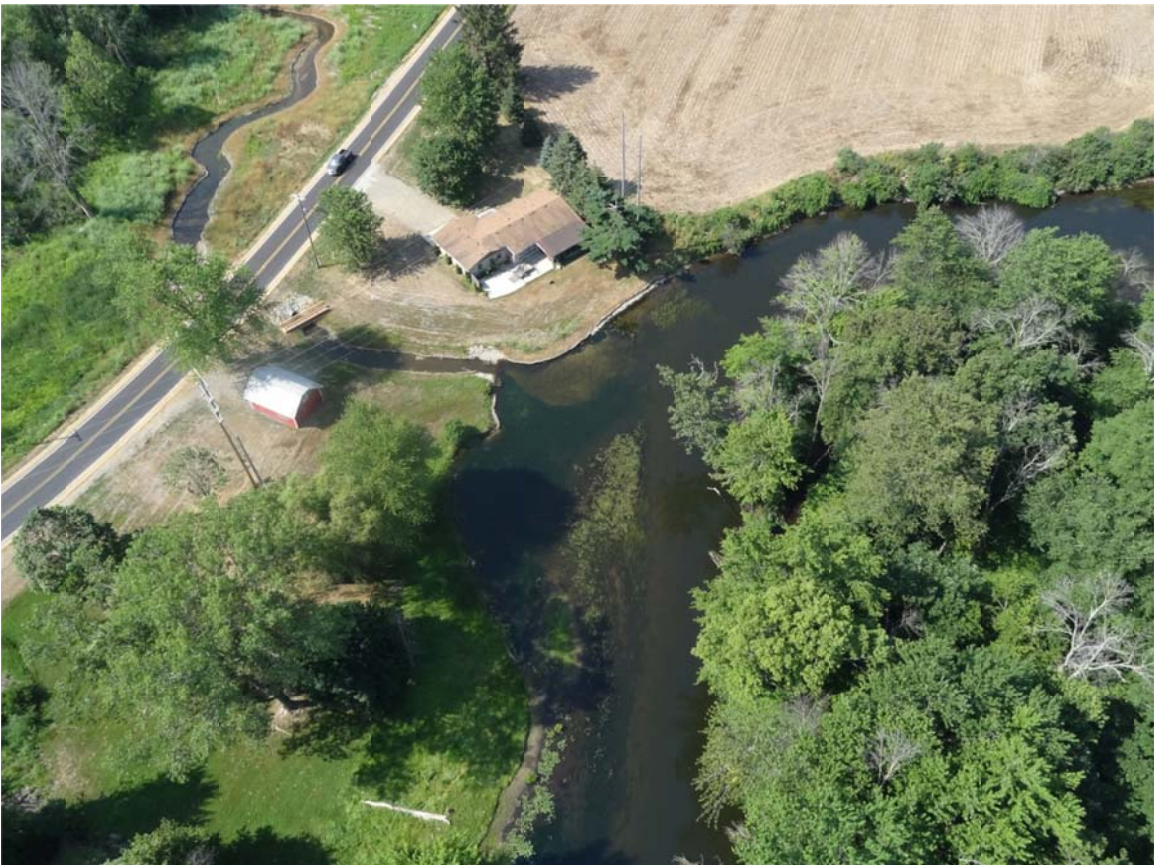
4. Confluence, no sheen observed.

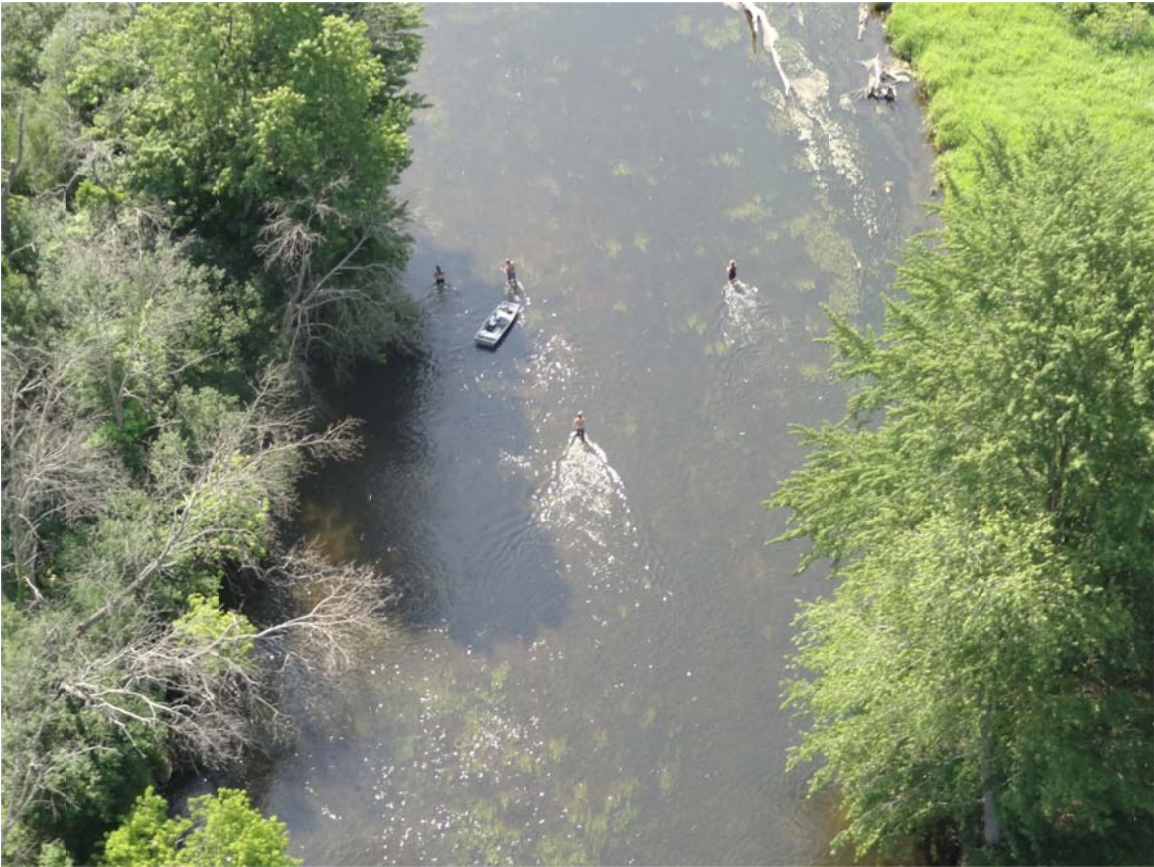
5. Observed fishermen in river just downstream from Saylor's Landing.

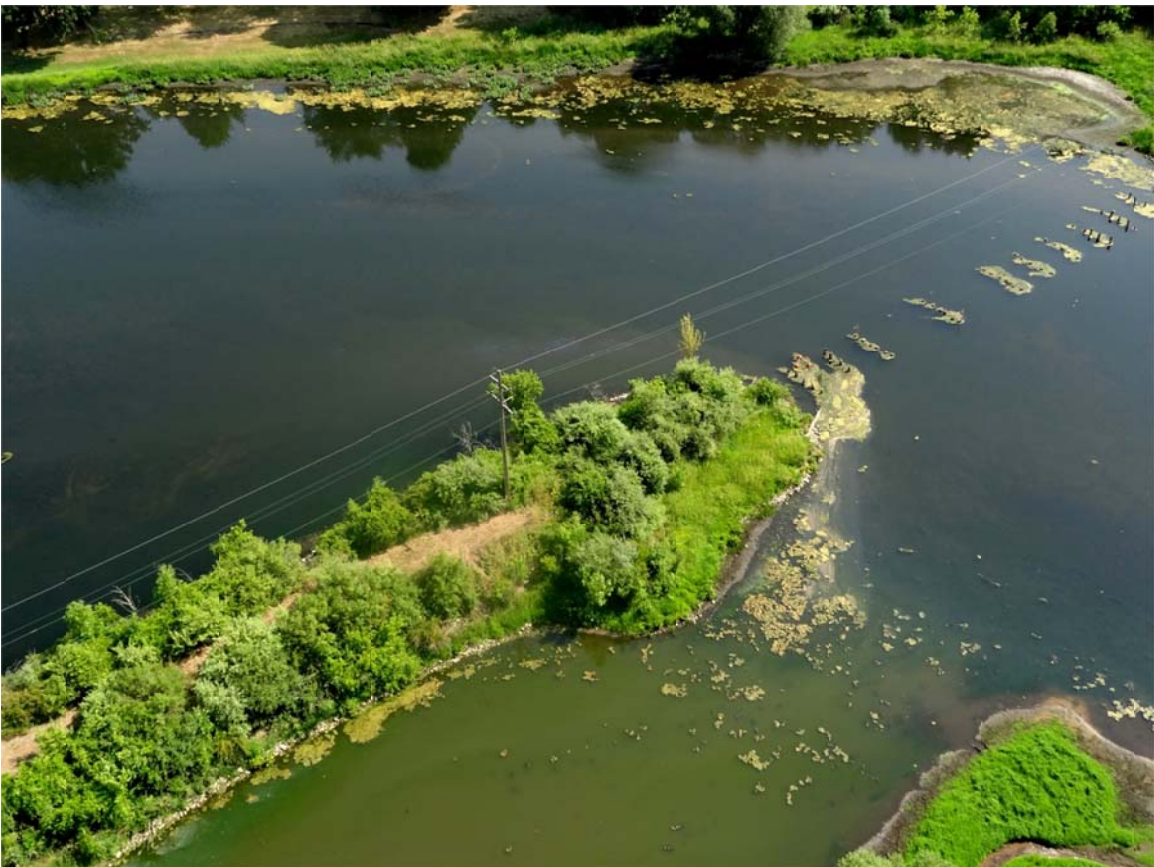
6. South peninsula above Ceresco Dam, observed sheen on upstream and downstream sides of peninsula. Sheen sweep boats were notified.

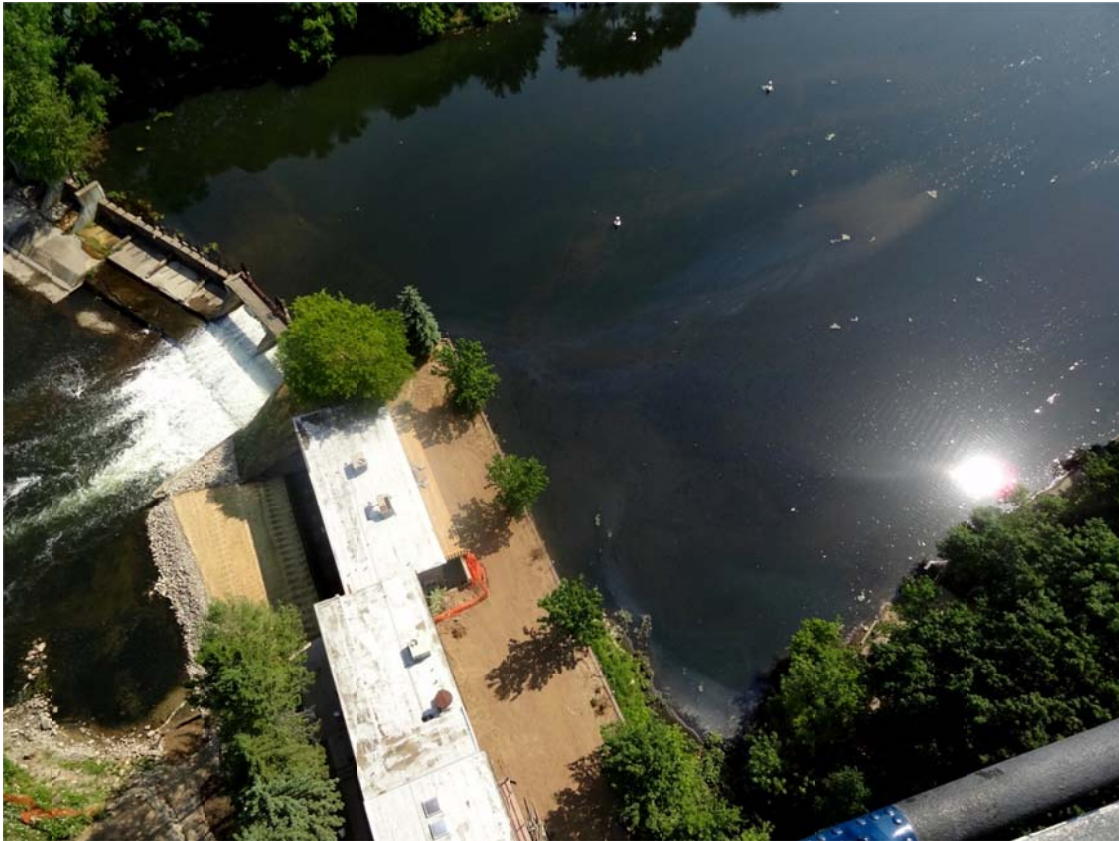
7. Sheen observed above Ceresco Dam. Sweep boat was observed operating in the area.

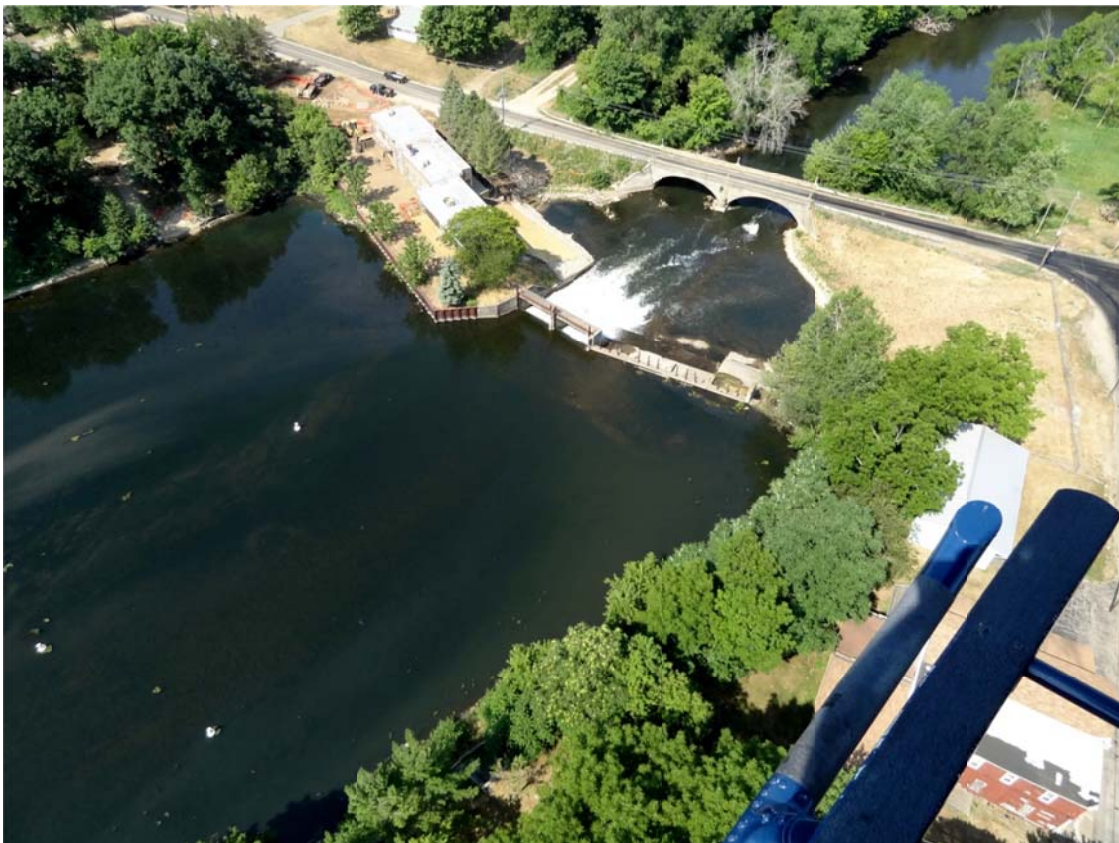
8. Ceresco Dam, sheen observed in southwest corner above dam and in river channel. Sheen sweep boats were present.

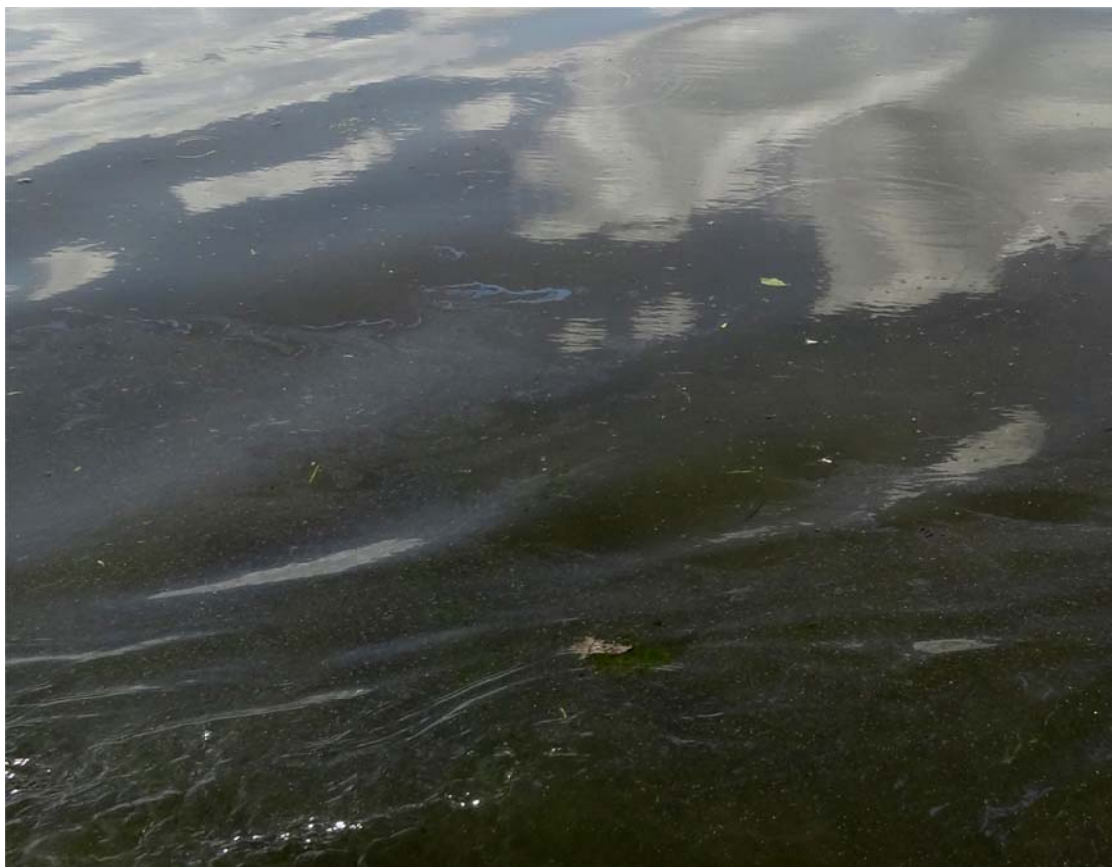
9. MP 5.25 LDB, sheen observed along southern shoreline above Ceresco Dam.

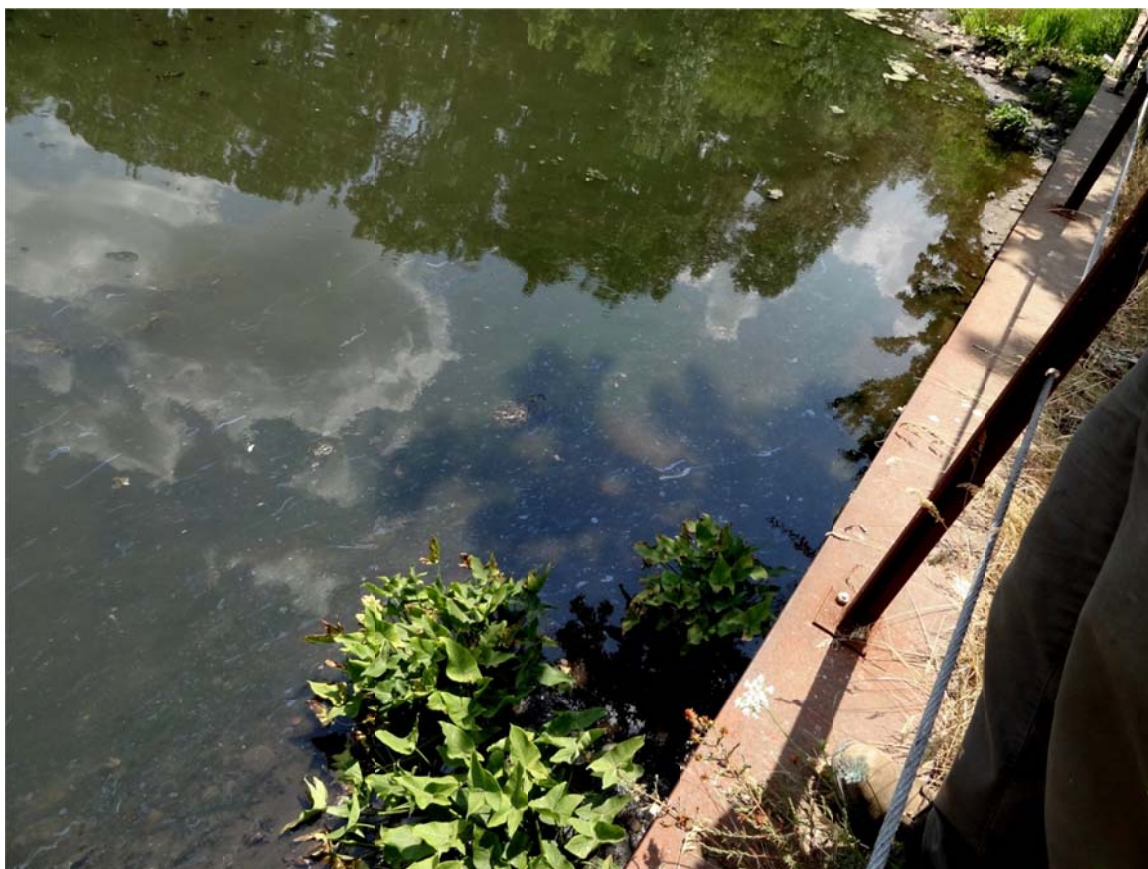
10. Ceresco Dam, sheen observed along the LDB along the southern wall of the dam.

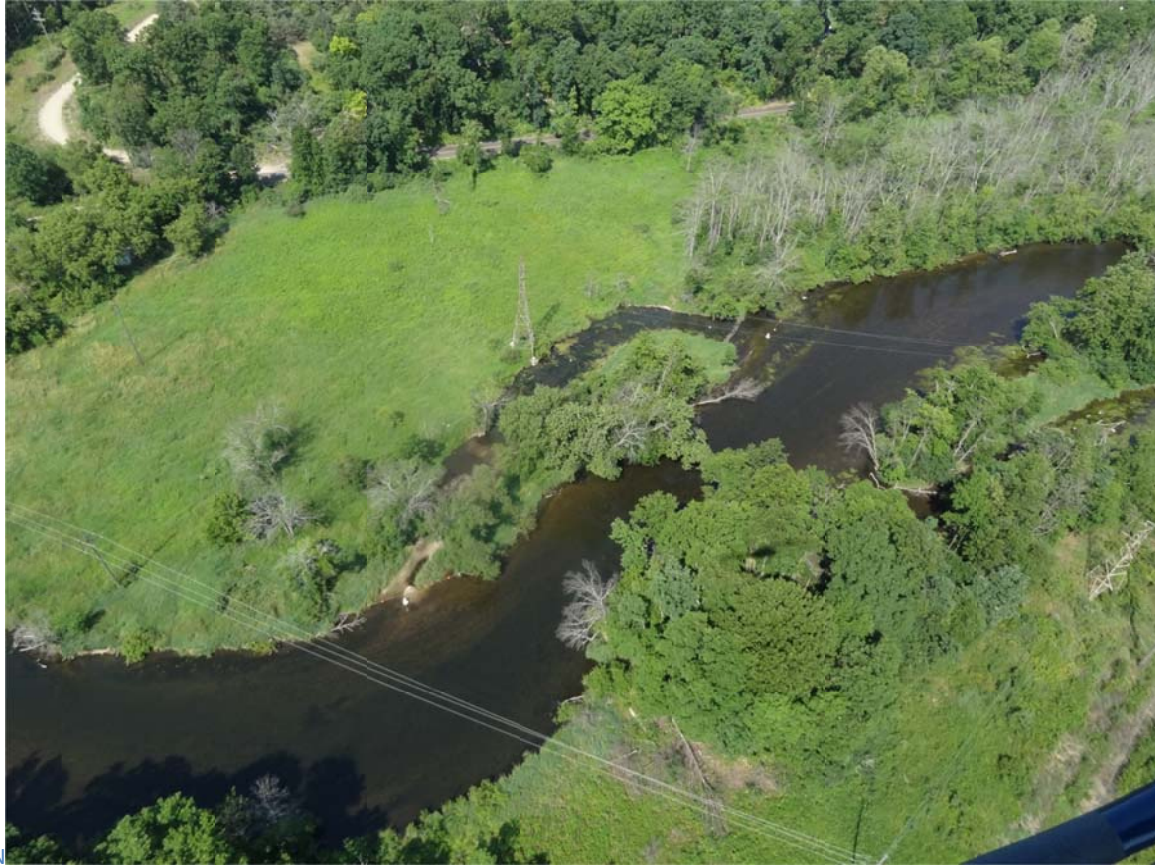
11. MP 10.75 sediment trap. No sheen observed.

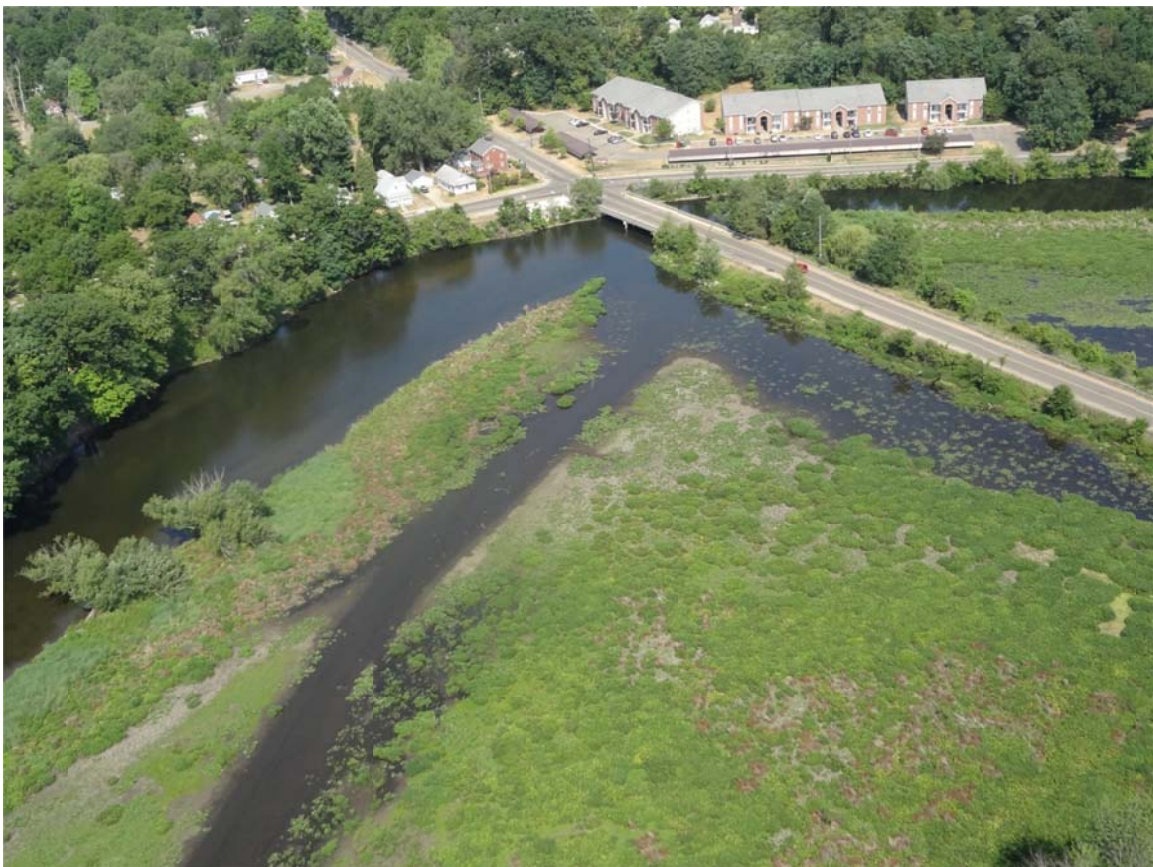
12. South end of Mill Pond, no sheen or activity observed.

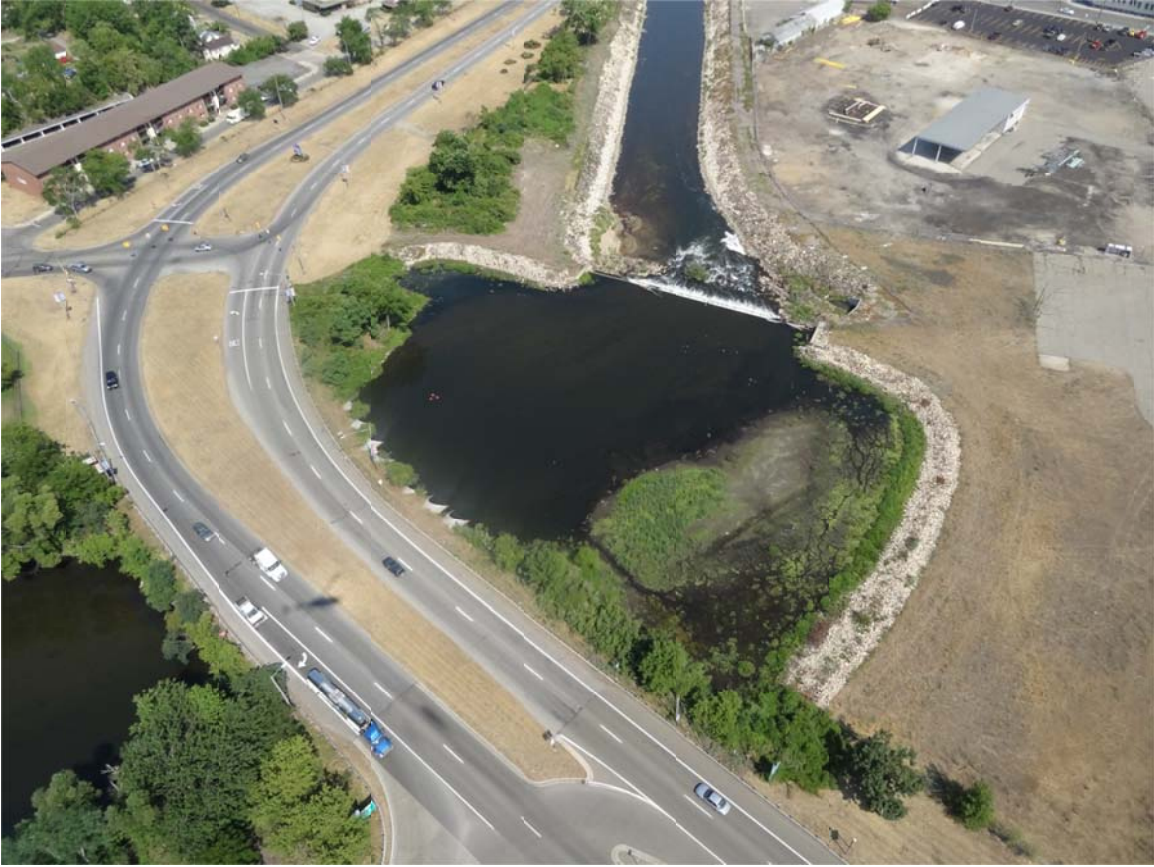
13. Battle Creek spillway, no sheen observed.

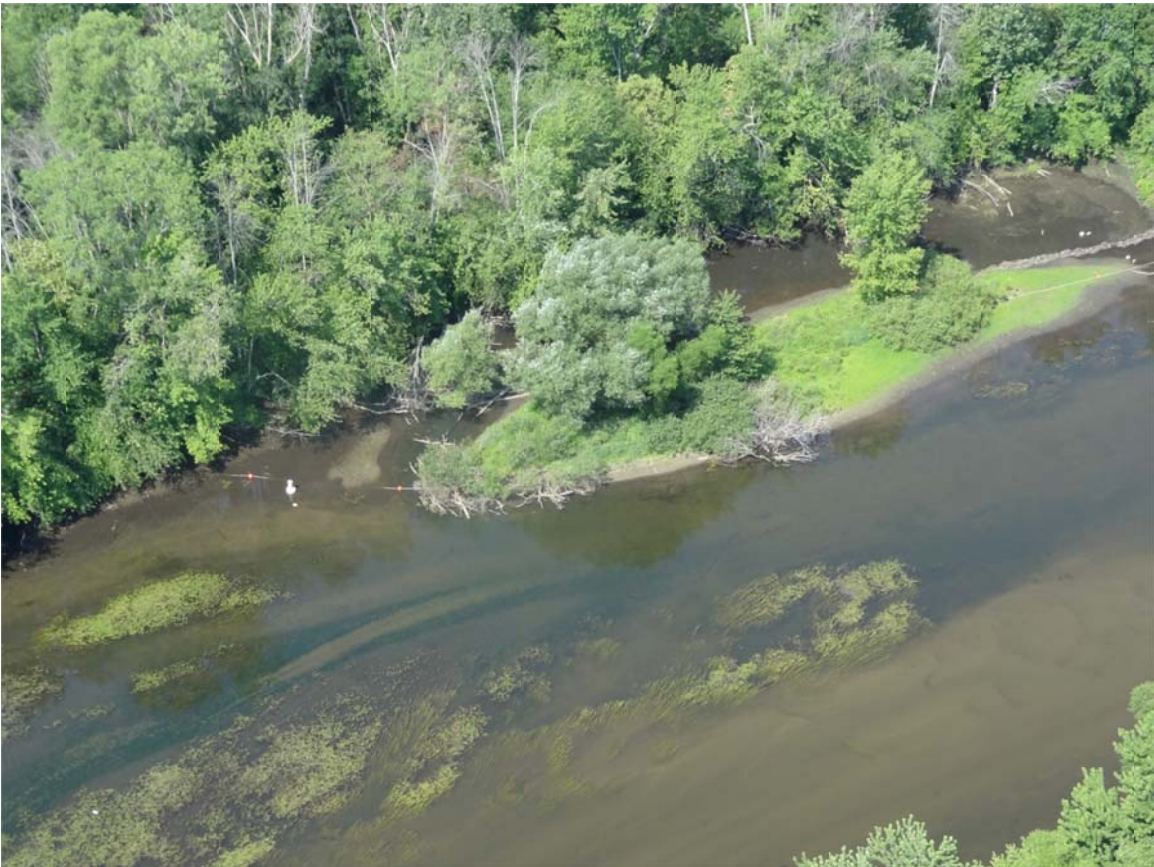
14. MP 19.25 sediment trap, no sheen observed.

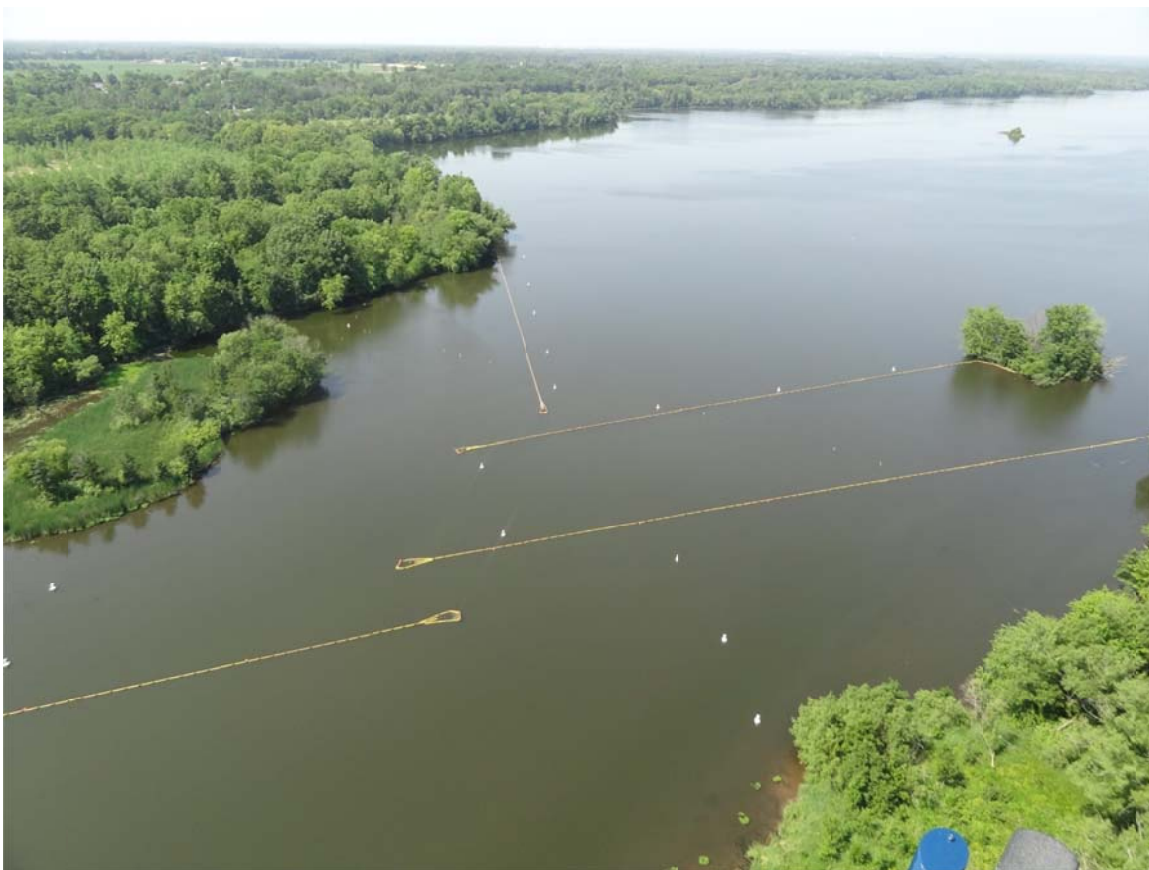
15. Morrow Lake Delta, current configuration of E4 Boom System.

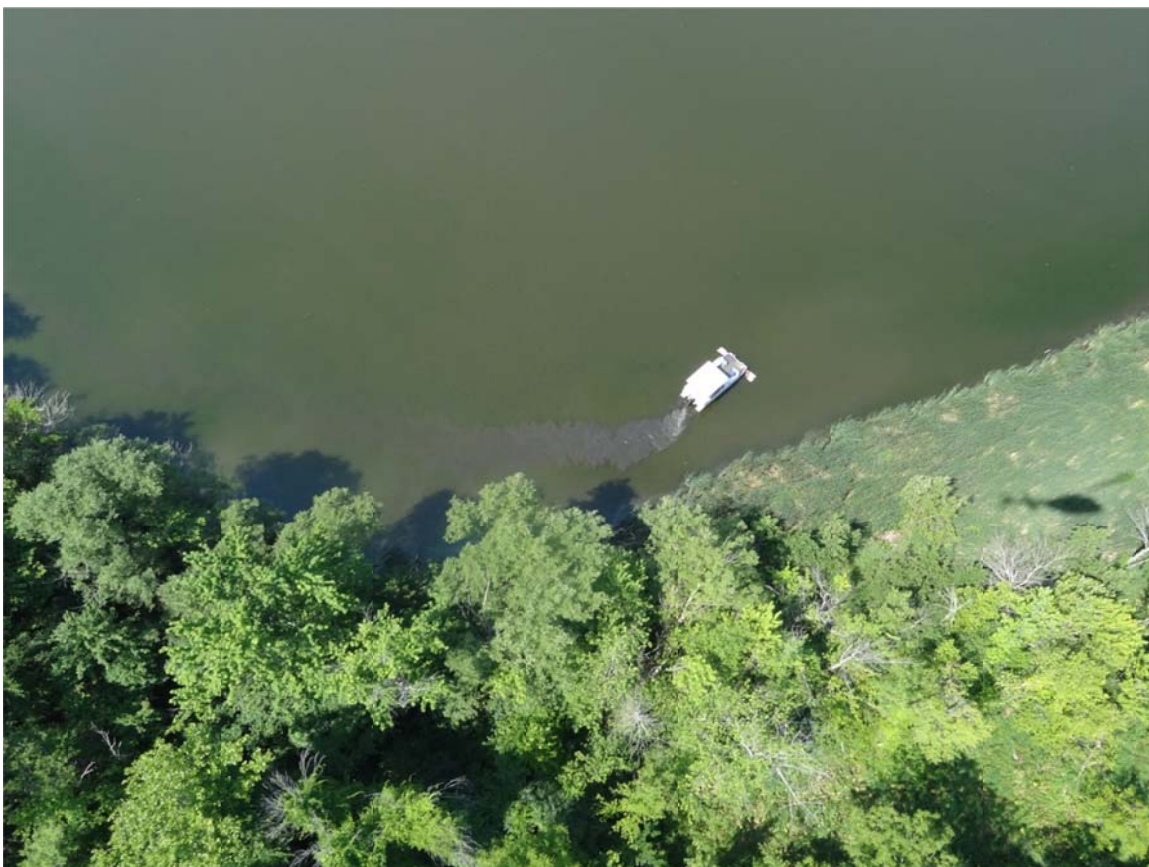
16. Sweeper boat operating in northern cove on Morrow Lake.

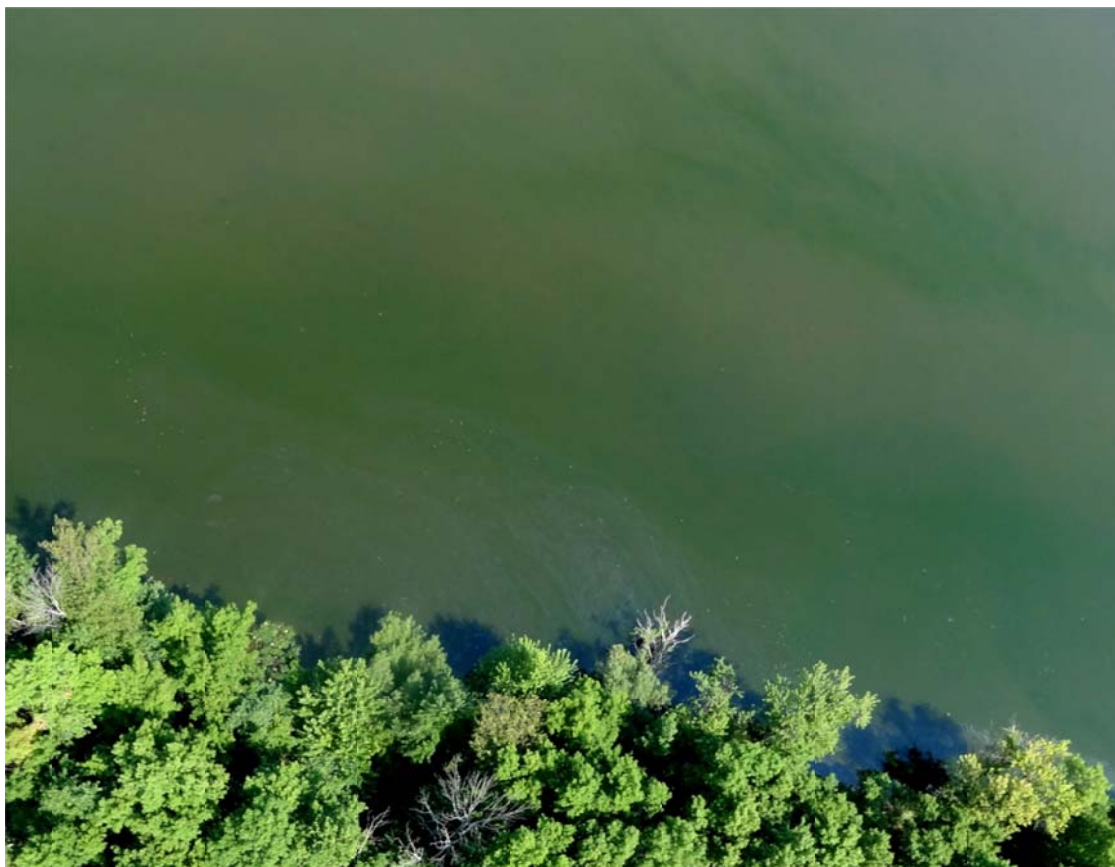
17. Morrow Lake, sheen observed along southern shore south of fan.
Sweeper boats were notified.

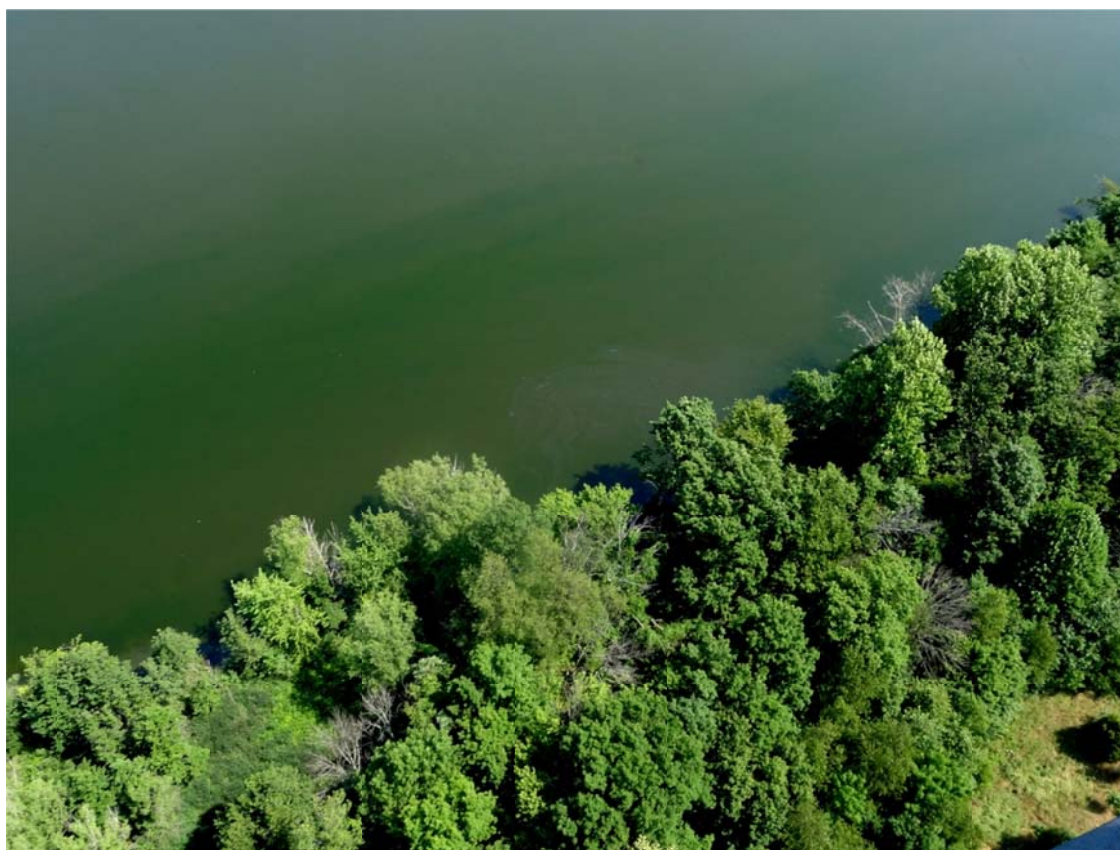
18. Morrow Lake, sheen observed along southern shore south of fan.
Sweeper boats notified.

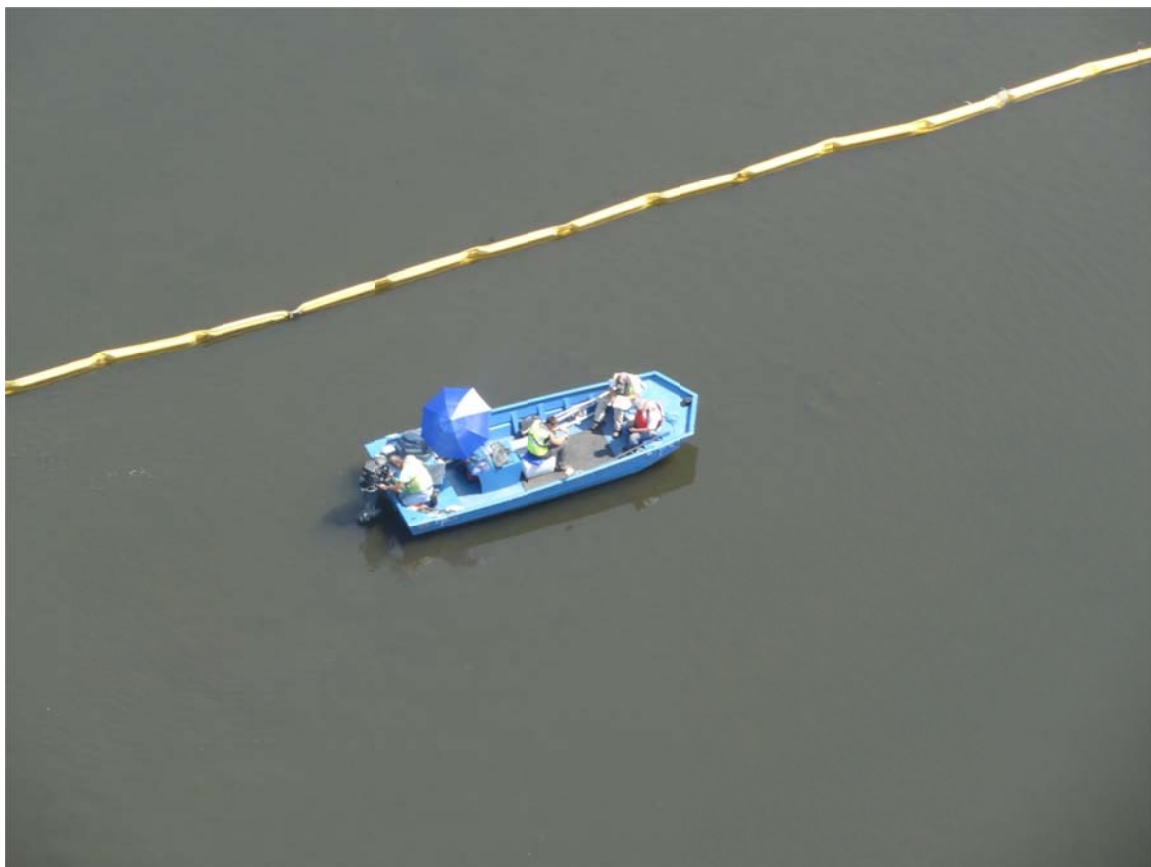
19. Morrow Lake Delta, poling crew in southern end of delta.

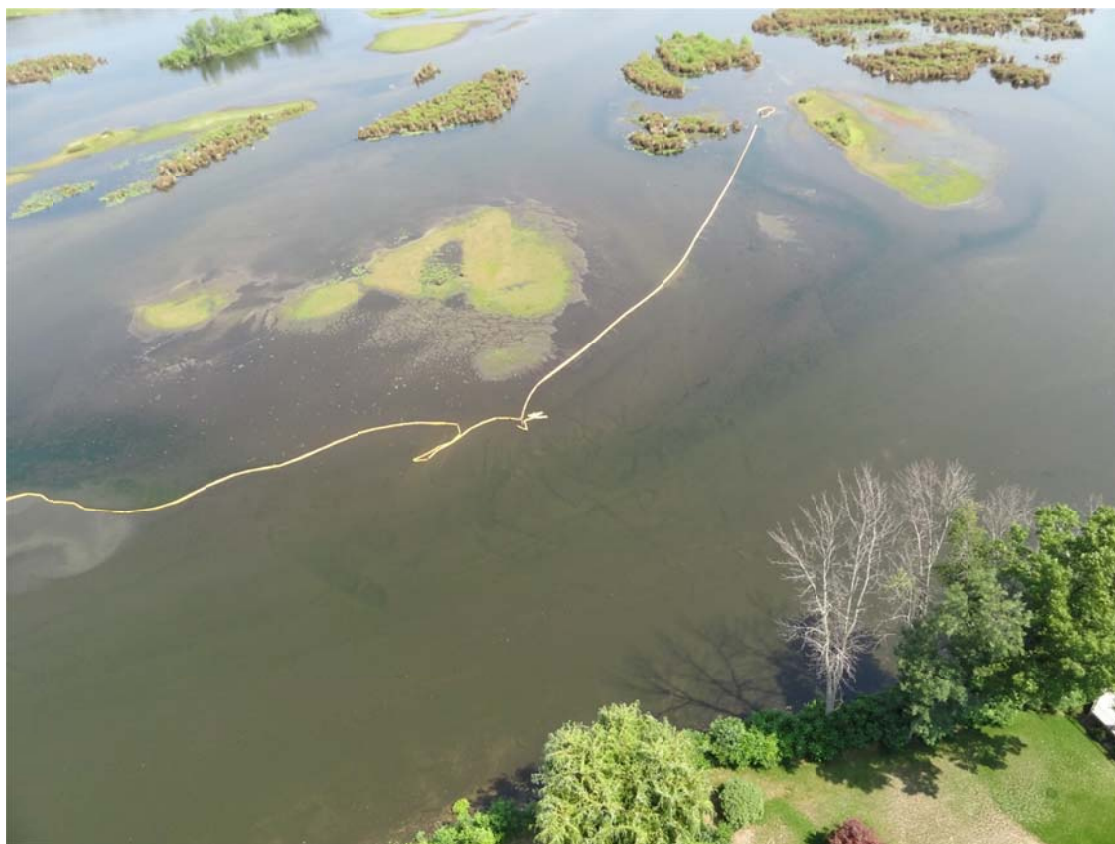
20. Morrow Lake Delta, containment boom staged for installation.
